Dutch Risk Reduction Team:
Reducing the risk of water related disasters

DRR-Team Mission Report

Mozambique – Licungo Basin

15 June 2015
DRR-Team Scoping Mission, Final Report
Flood Control in the Licungo Basin of Zambezi Province

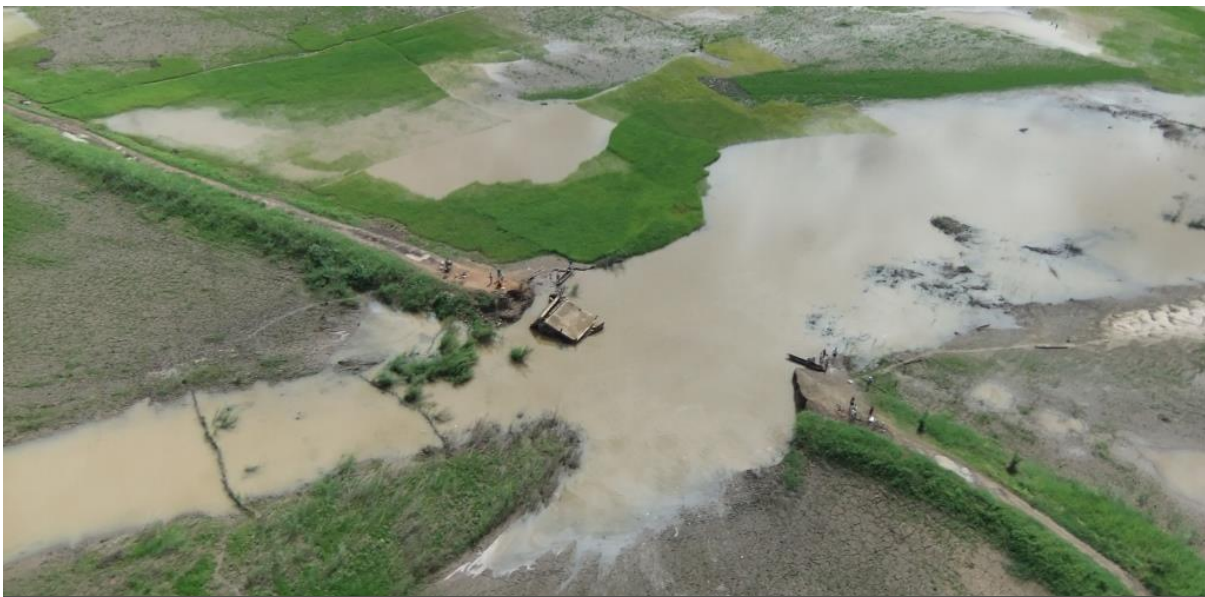
Figure 13 – Collapsed Bridge and Breach at Naminane

Because of the breach and the collapsed bridge the connection of the road was closed. The distance covered by the team was 2 kilometres up to this breach. The team could not cross the breach (is a lake) by canoe because of government safety restrictions applicable to the DRR-Team members.

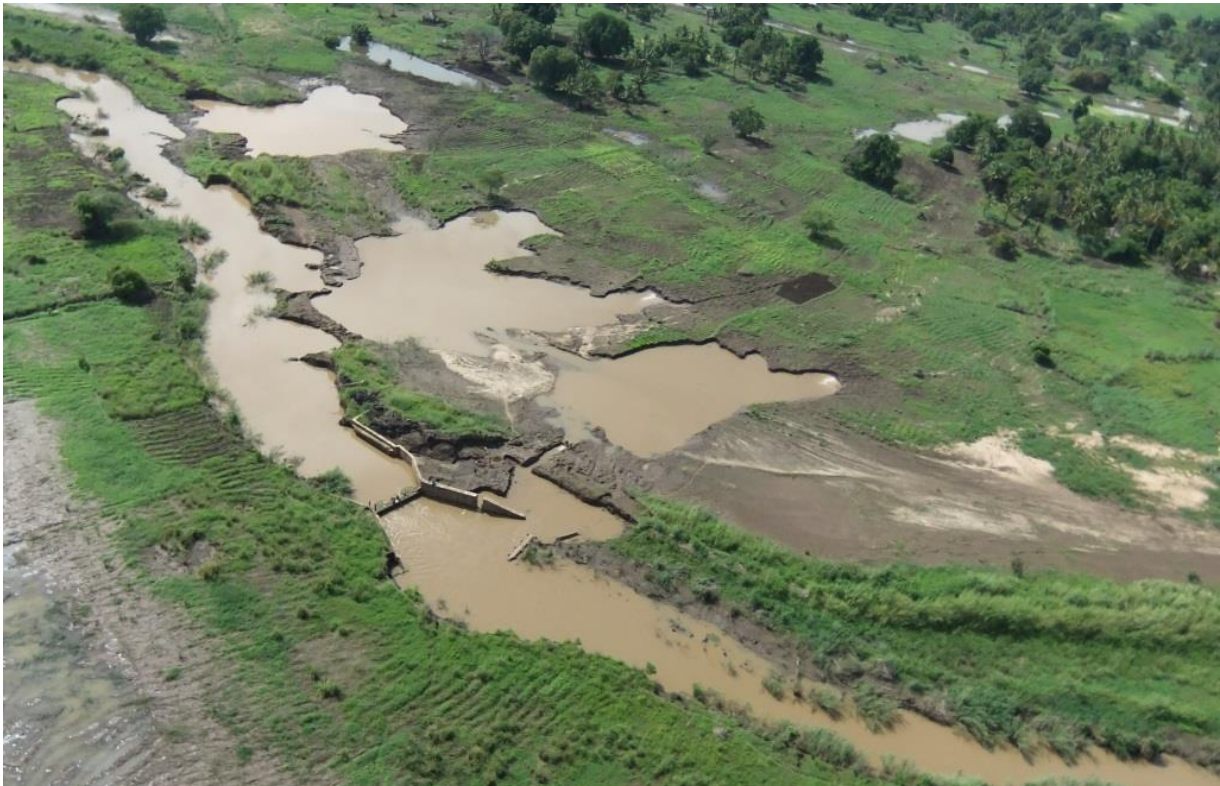
Figure 15 – Eribacila Weir in the Cune River

the weir have wing walls downstream and upstream of the barrier. The weir and surrounding were totally submerged by the floods of 2015. This place was not visited by the DRR-Team because of difficult access conditions.

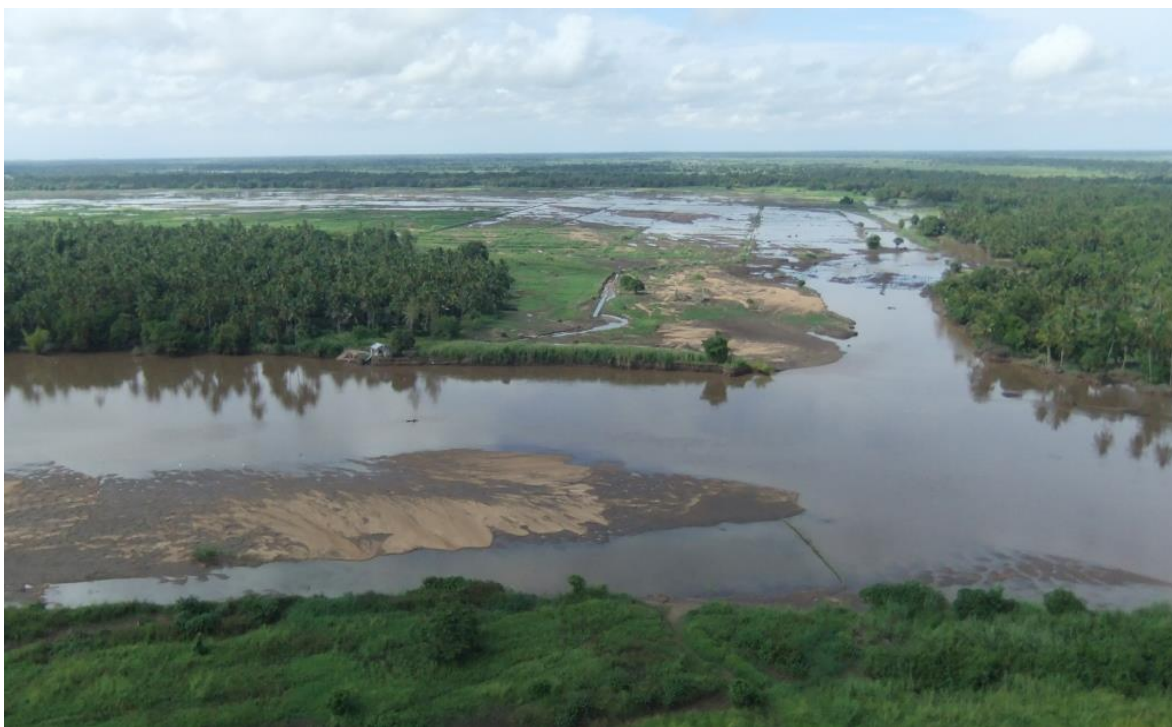
Figure 17 – Intabo Intake Station, Canal and Breach

The Intabo intake structure, see Figure 16, serves a vast irrigation scheme. The structure is located in the outside curve of the Licungo River, where the current of the flood waters has a heavy impact on that left bank representing a high risk of erosion. This led to the rupture of the downstream dike over at least 150 meters (Item 60 of cost estimate) and a big influx of water (actually a "new" river) into the irrigation scheme behind the dike, see Figure 17. As the new river blocked the access to the rest of the dike the DRR-Team was forced to stop here and return to Nante. The soil necessary for the restoration of the dike is not locally available and has to be taken from a place close to the semi-circular loop not far from Nante, distance about 6.5 Km. Topographic surveys should be executed in all areas so as to know the dike, structures and field levels.

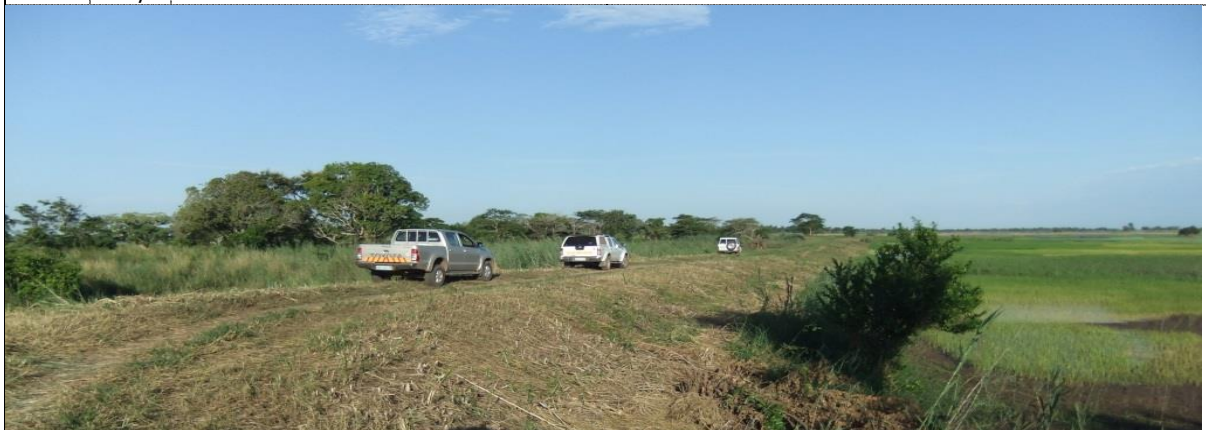
#	DATE	LOCATION	#	DATE	LOCATION
	15/4	Naminane Dike

View from the start of the semi-circular dike. This part of the dike is lower and has been overtopped by 1.80m of water. The sediment right side of dike was deposited by the floods.

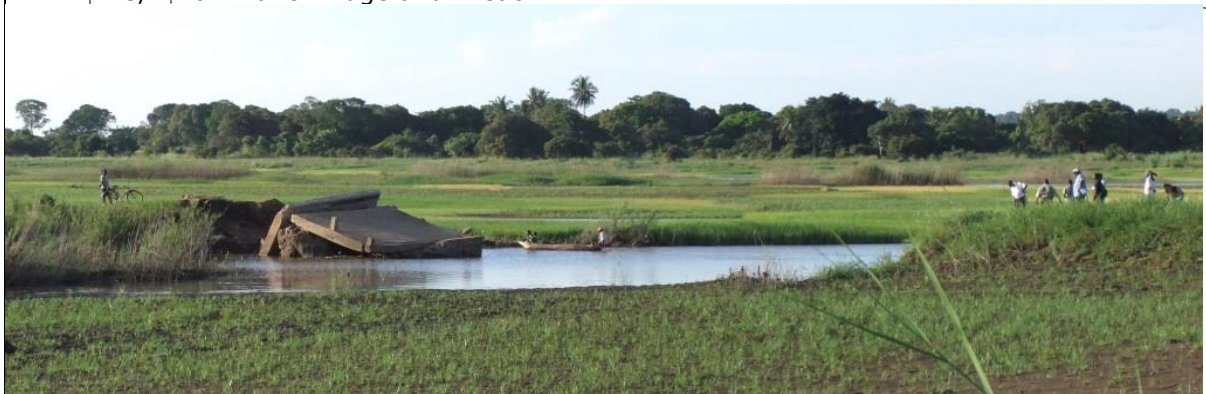
1+2 | 15/4 | Naminane Bridge and Breach

The concrete bridge was broken and inhabitants cross the breach by canoe

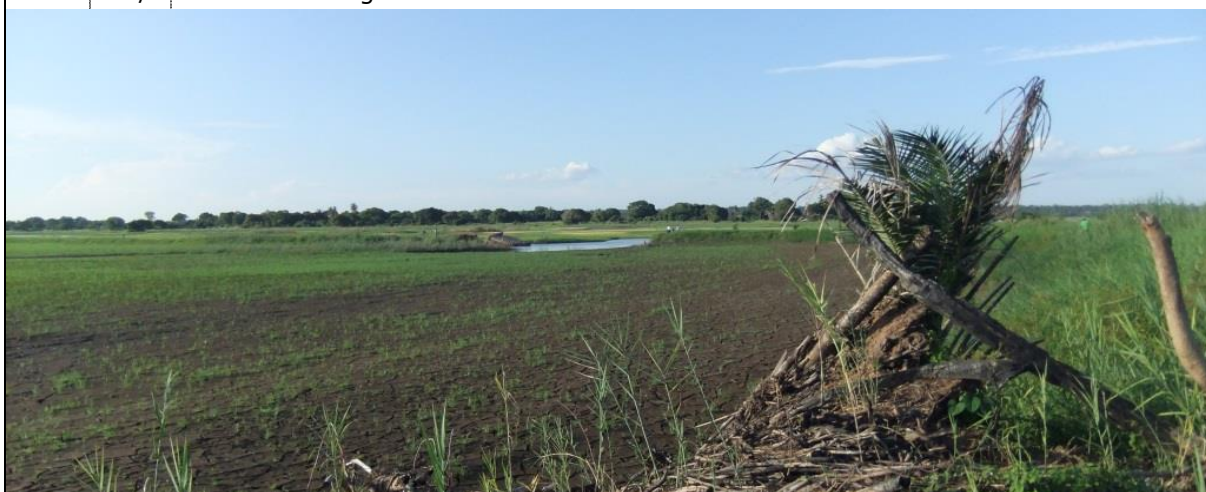
1+2 | 15/4 | Naminane Bridge and Breach

The grasses and debris in the palmtree show the level of the flood. The brown soil was freshly deposited by the 2015 flood.

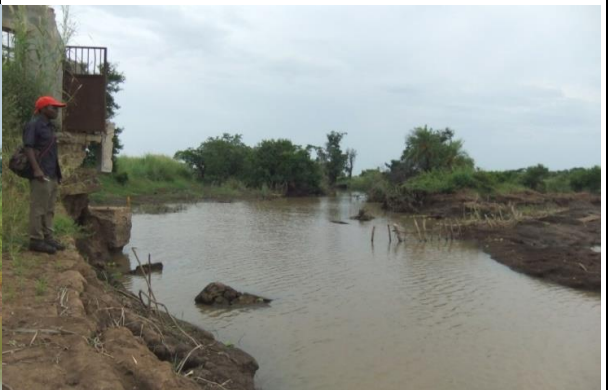
Partly destroyed intake station with pump (blue).			Where Xavier is standing started a dike to the far right. The intake station is partly destroyed.		
26	16/4	Dique Valintin	26	16-4	Breach at road crossing Munda Munda

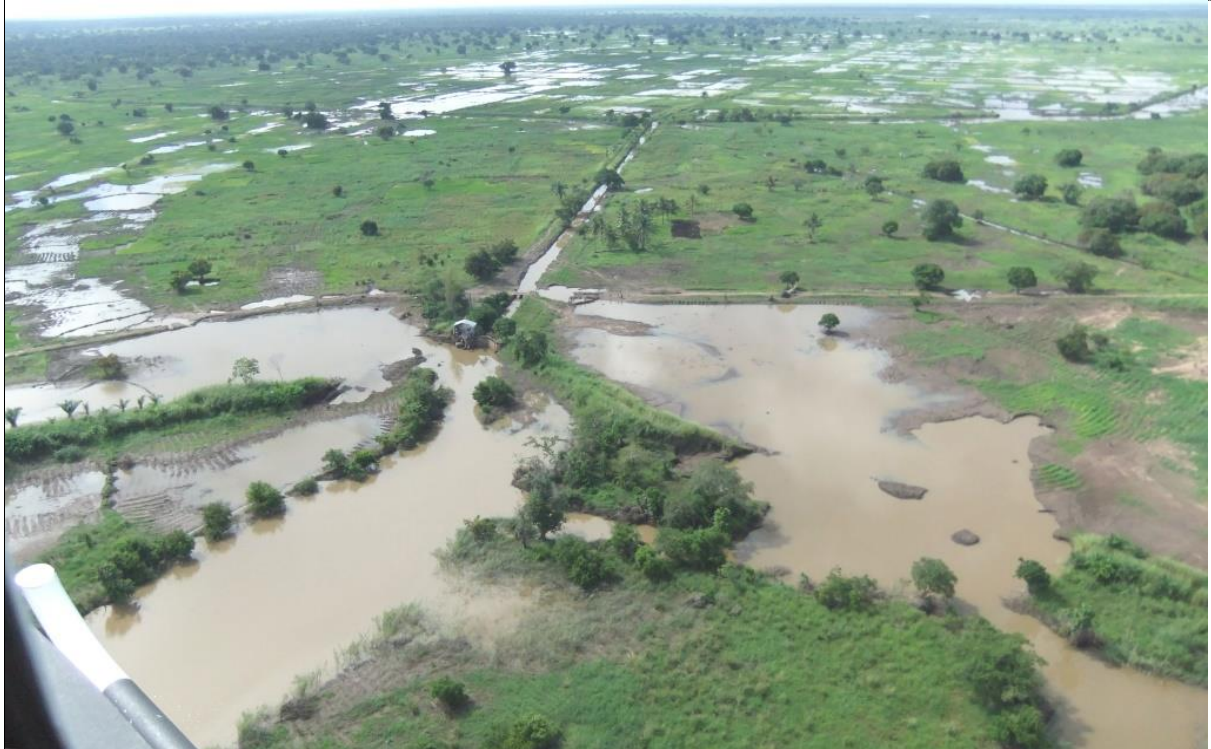
Munda Munda					
-------------	--	--	--	--	--

The intake station of Munda Munda is situated in the center of this aerial view. The road crosses the picture from far right to far left in the middle of the photo. The intake canal and the irrigation scheme are visible in the back ground. The intake section of the river is shown in the left-bottom corner. The continuation to the right (down stream) of the dike stretches from the station to the the right-bottom corner of the picture and is severely damaged. This dike continues to Eribacila weir complex.

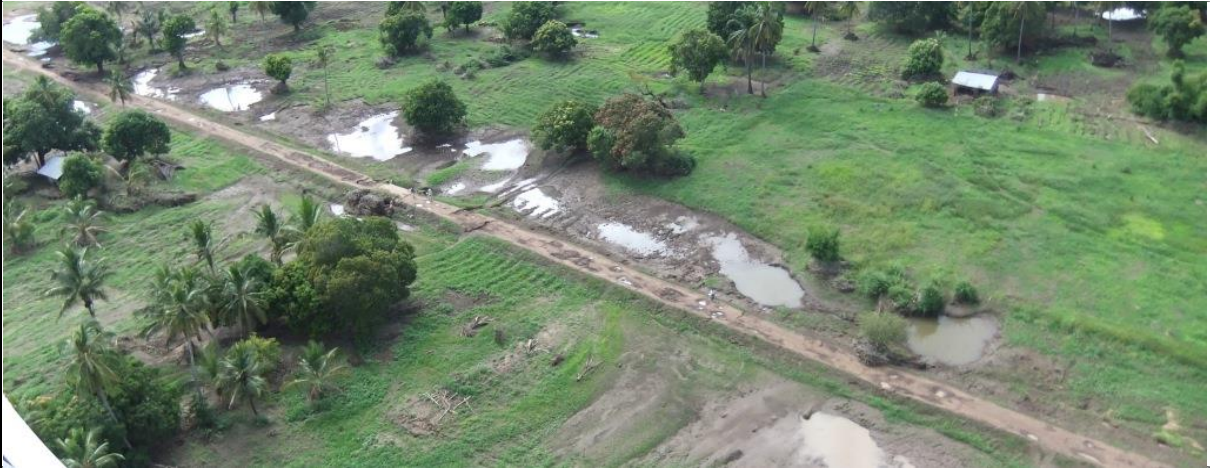
Road between Munda Munda and Muguloma

The top of the road is damaged by over flowing water over a length of 5000 m (Estimated) and will need repair so as to allow for passage of cars.

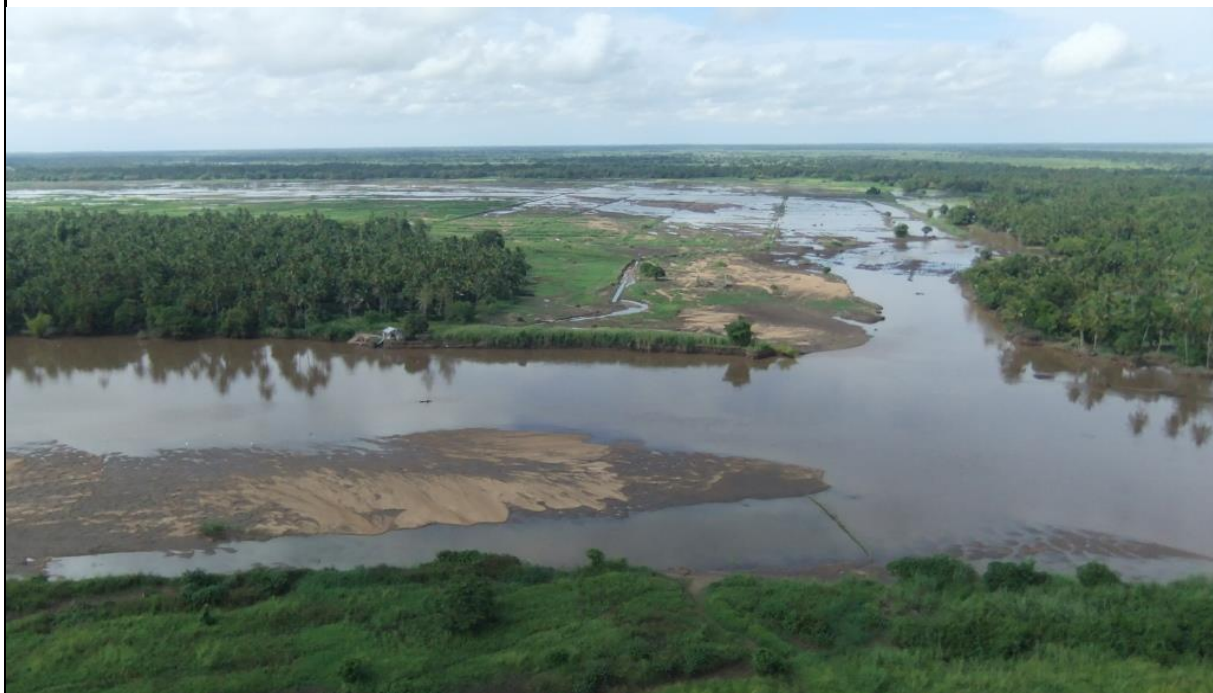
60	16-4	Intabo intake station
----	------	-----------------------

The intake station and the canal are visible at the edge of the trees. The river that diverts to the left was created by the flood and inundated vast areas inland. The dike is broken over some 150 meters. The agricultural experts raised the question whether the dike should be re-installed or that an other solution is to be designed.

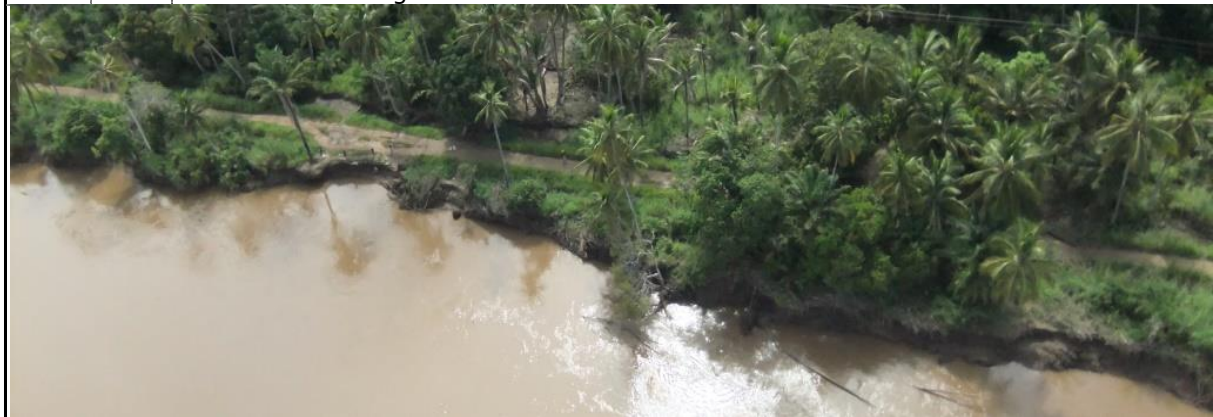
53-57	16-04	River berm of Muguloma
-------	-------	------------------------

Before arriving at Intabo the road borders the river very closely. In many places the berm has been eroded by the water, probably not only by the last flood of 2015. The houses of the inhabitants of the zone lay behind the road. In order to safeguard the road action should be taken to protect the berm. The installation of Gabions may give a mid-term solution. In case the road is to serve more traffic in future more permanent works may be necessary.

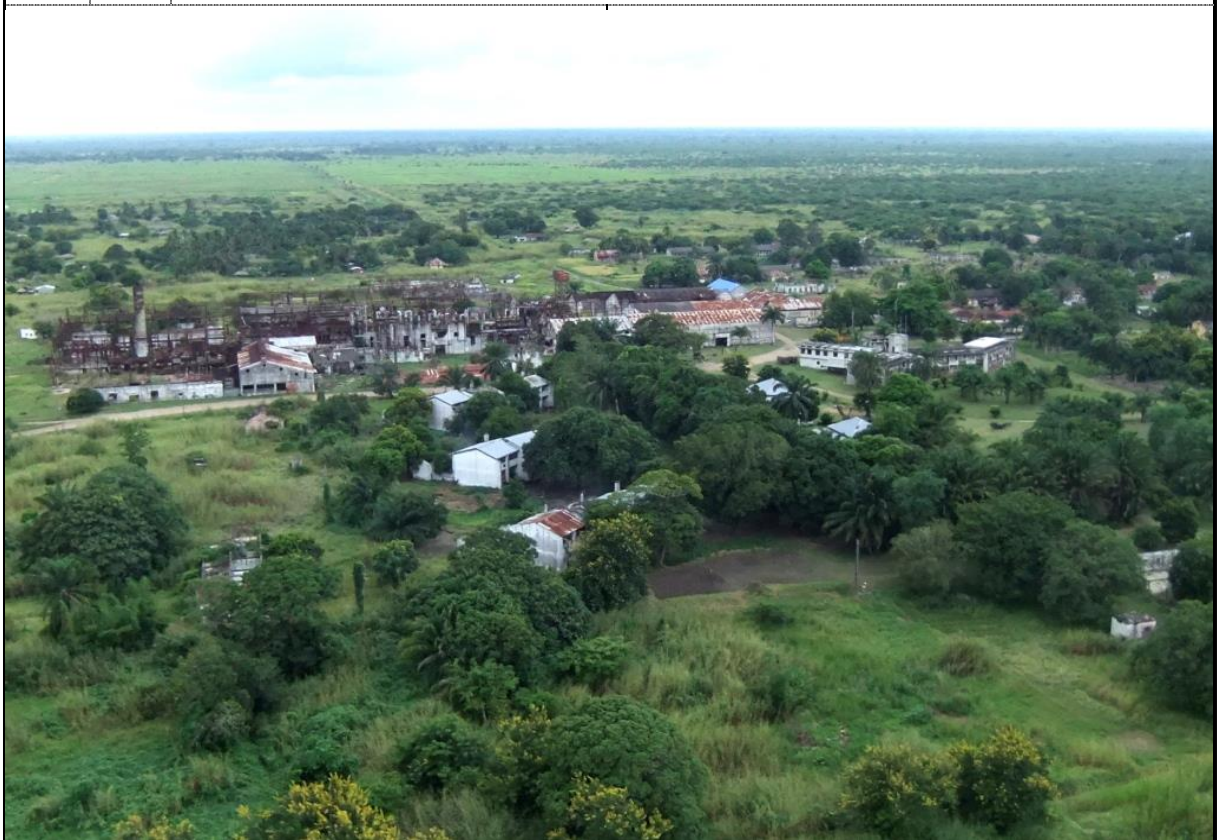
17-4 Town of Luabo

The town of Luabo seems abandoned. Fields in the surrounding do not seem to be used. No major breaches were seen in the dikes during the flight. Detailed surveys on the ground may show hidden damages, also originating from earlier floods.

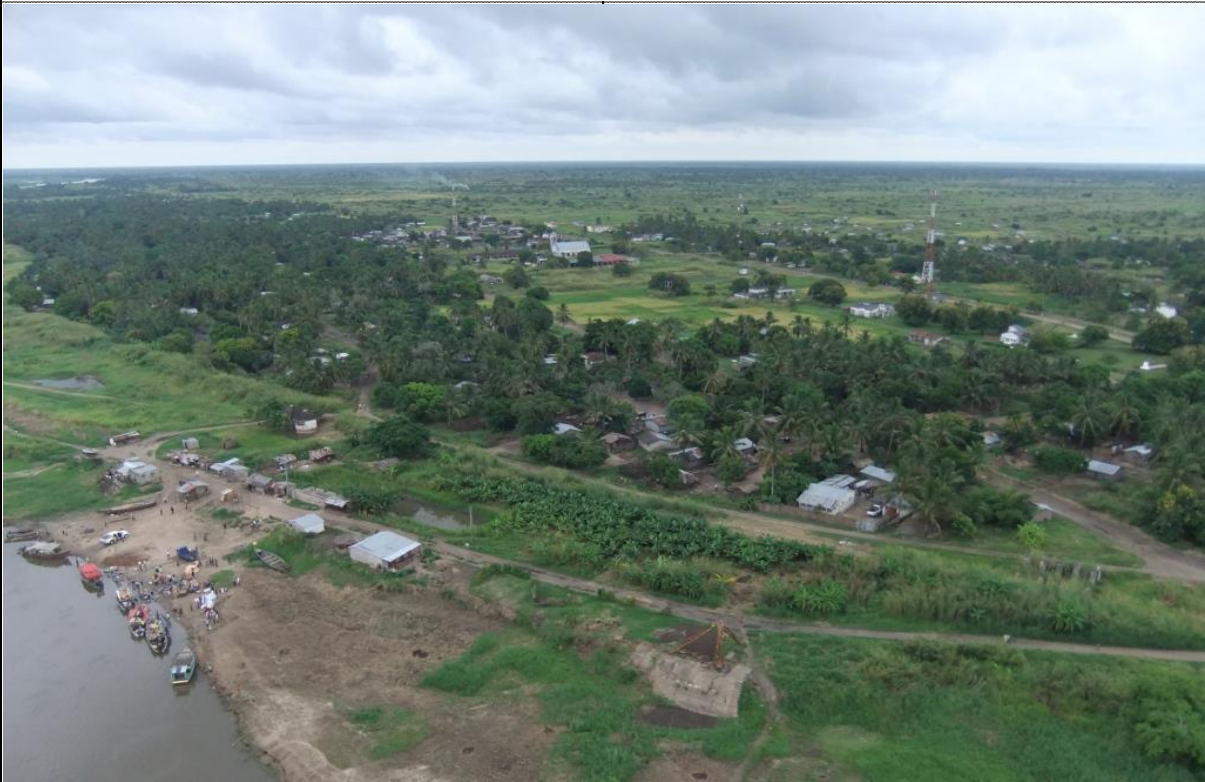
17-4 Town of Mopeia

The dikes visible on this picture seem to be intact and heavily overgrown by greens. On several parts crops are grown on the sides of the dike. This practice should be forbidden as it degrades the quality and the level of the dikes..

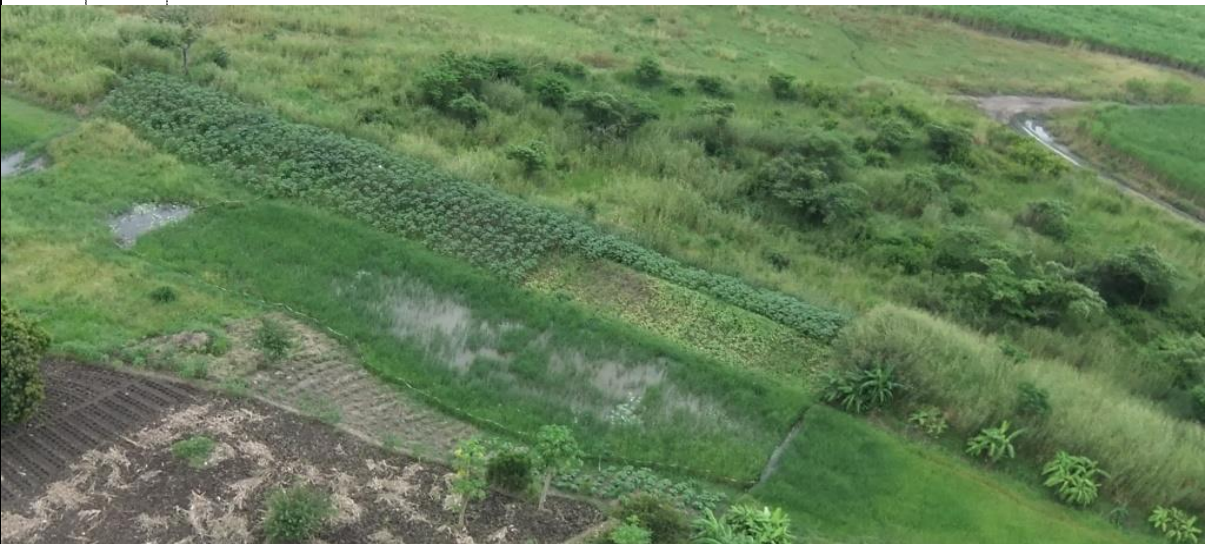
17-4 Dikes in the vicinity of Marromeu

The dikes in the surroundings of Marromeu do not show major breaches. In general the dikes are overgrown with greens, mainly elephant grass. On several places agriculture is being practiced. This should be forbidden as it degrades the quality and the level of the dikes.

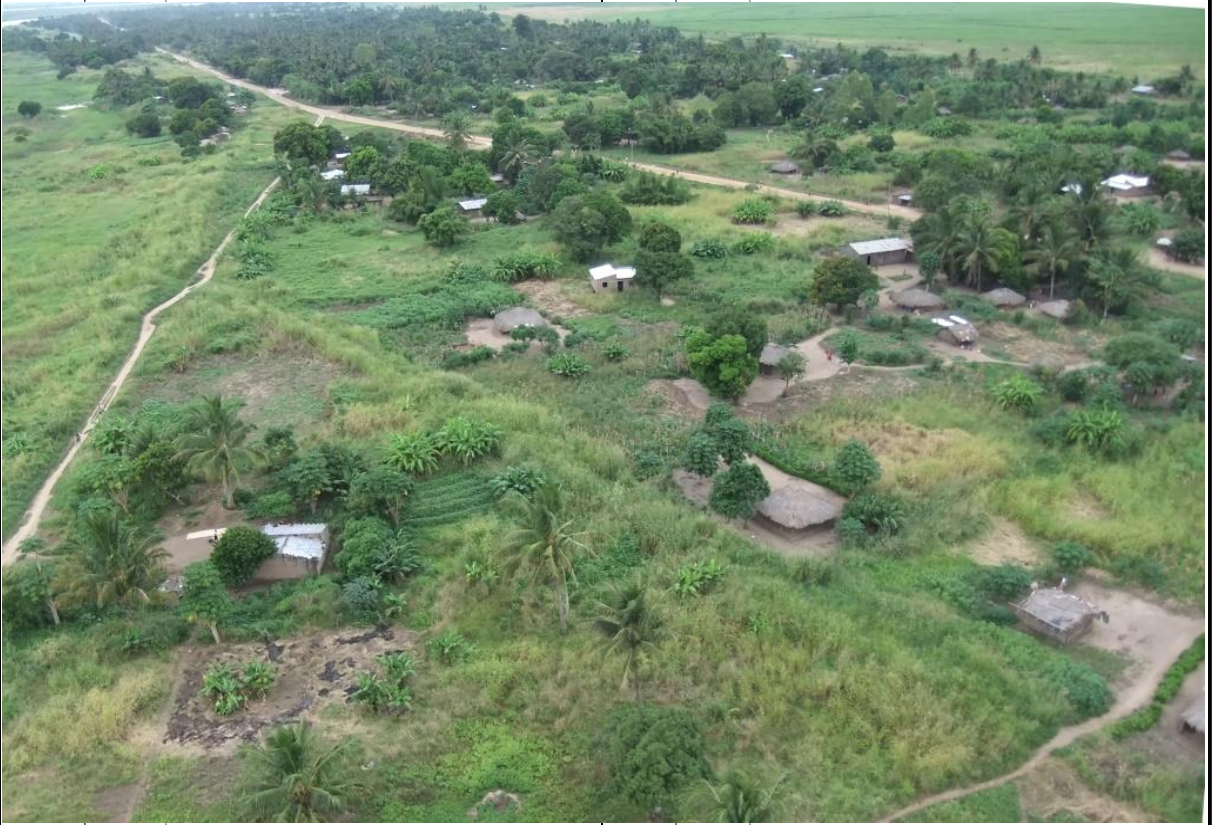
#	DATE	LOCATION
17/4	17-4	Surrounding of Marromeu

The dikes visible in this picture do not show major flood damage and seem to be over grown with grasses for several years.
